Fine Point Home Inspection

Property Inspection Report

0000, Brentwood TN, 37000
Inspection prepared for: Mr. Buyer & Mrs. Buyer
Agent: Tonya Greer - MILLION DOLLAR SELLER

Inspection Date: 1/5/2010

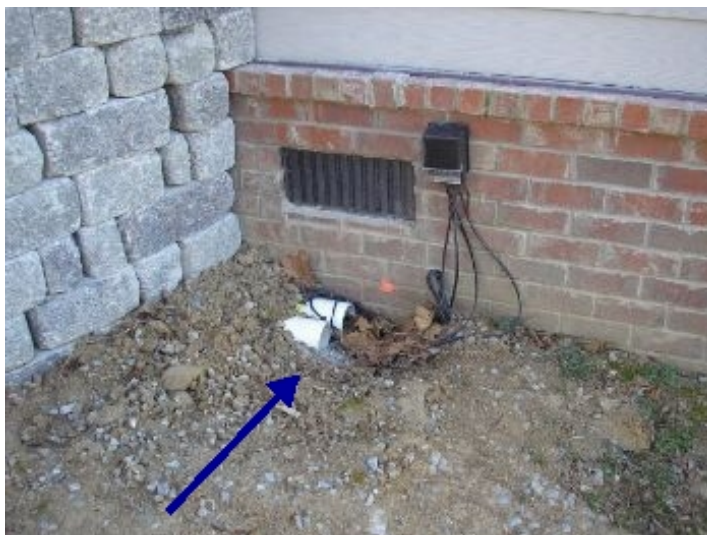
- Gutters and downspouts are aluminum.
- Failure to properly control roof water runoff can result in water accumulating around the home's foundation--and in basements or crawl spaces. Accumulated water is a conducive condition to wood destroying insects and organisms, and may also cause the foundation to settle and possibly fail over time. Gutter downspouts which discharge onto the ground--above grade--should be extended at least 4' to 6' feet away from the house, or more if possible. The slope of the ground in this area should fall away from the house to direct water from the foundation. If possible, consider installing and/or repairing tie-ins to underground drain lines.
- **Remedy as needed: One or more downspouts have no extensions, or have extensions that are ineffective. Potential water intrusion and damage to foundation. Repair as needed.**

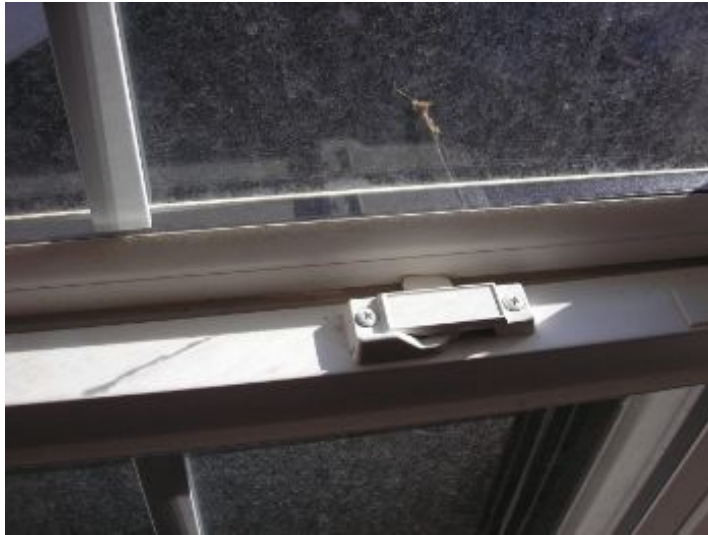
3. Window Condition

- A representative number of windows were inspected. More than one did not lock when tested. Recommend all windows be reviewed for proper operation during final walkthrough inspection.

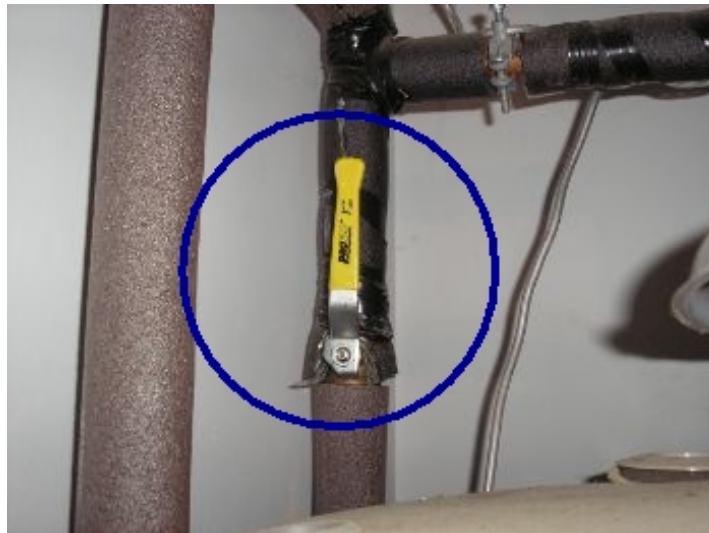
3. Main Water Shutoff

Location: Garage, behind water heater

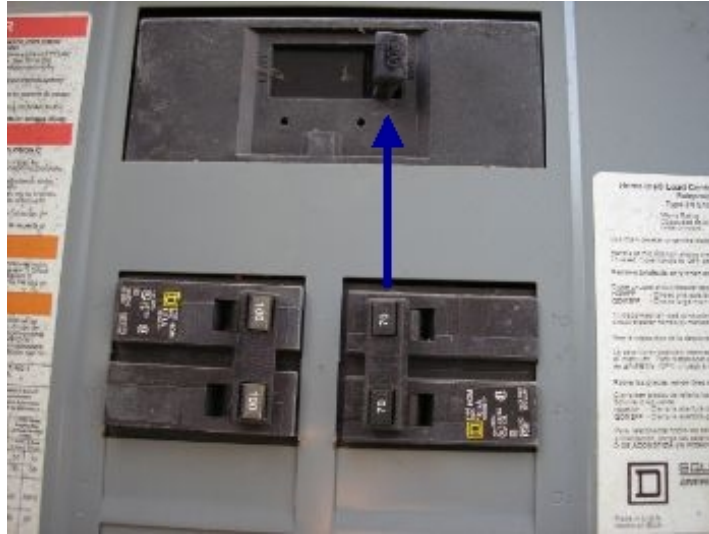
200 AMP shut off

Description: The 120/240 volt, service enters the house from conduit underground, Meter location is on an exterior wall

Conductors and Service Ratings: Aluminum, 4/0 AWG wire, 200 amp service rating

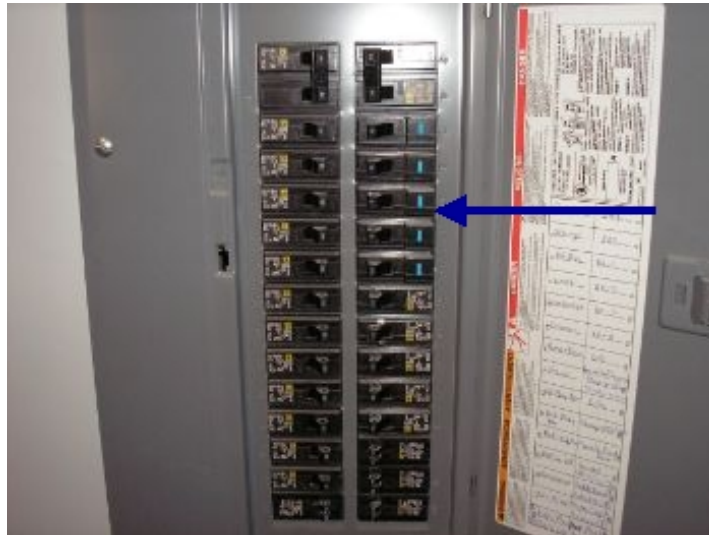
- Installed AFCIs responded to test.
- The AFCIs can be reset in the sub panel.

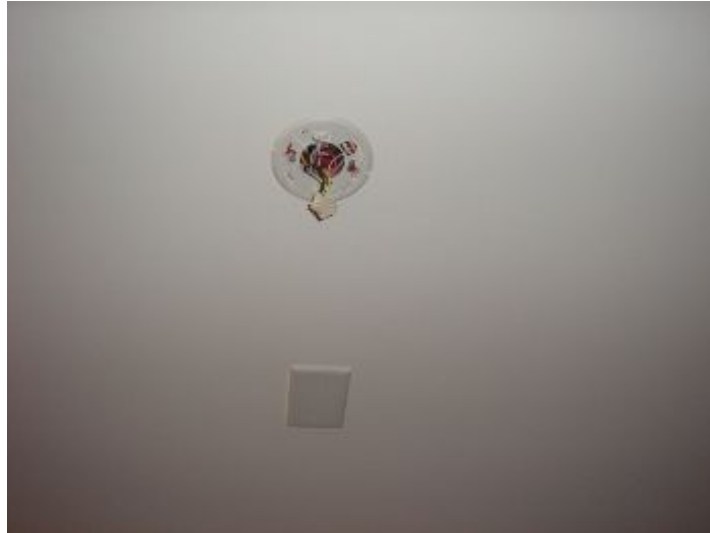
SAFETY CONCERN: Smoke Detector was missing in the garage. Recommend having one reinstalled.
